Docket No. 217 – Development and Management Plan Inspection

Northeast Utilities Service Company Certificate of Environmental Compatibility and Public Need for the construction of a 345-kV electric transmission line and reconstruction of an existing 115-kV electric transmission line between Connecticut Light and Power Company's Plumtree Substation in Bethel, through the towns of Redding, Weston, and Wilton, and to the Norwalk Substation in Norwalk, Connecticut.

Norwalk Substation

Date: October 13, 2006

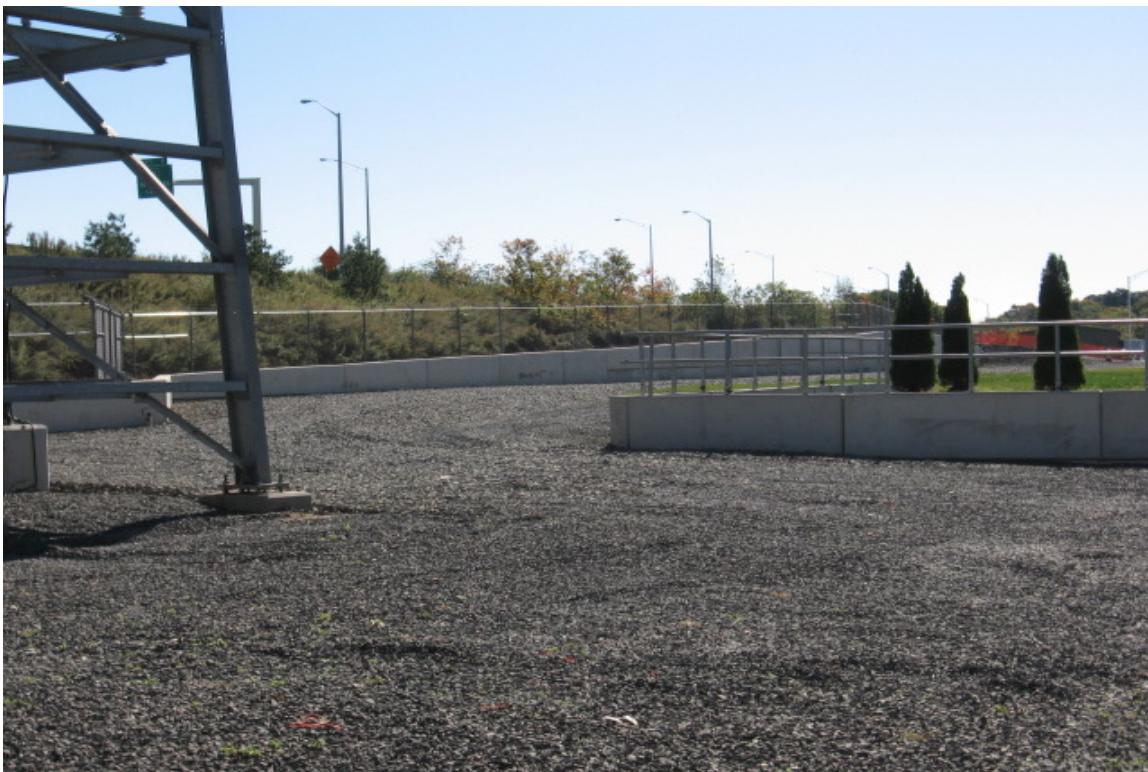
(Norwalk Substation): Photo shows a view of the additional stone spread throughout the substation yard and access drive. 10/13/06

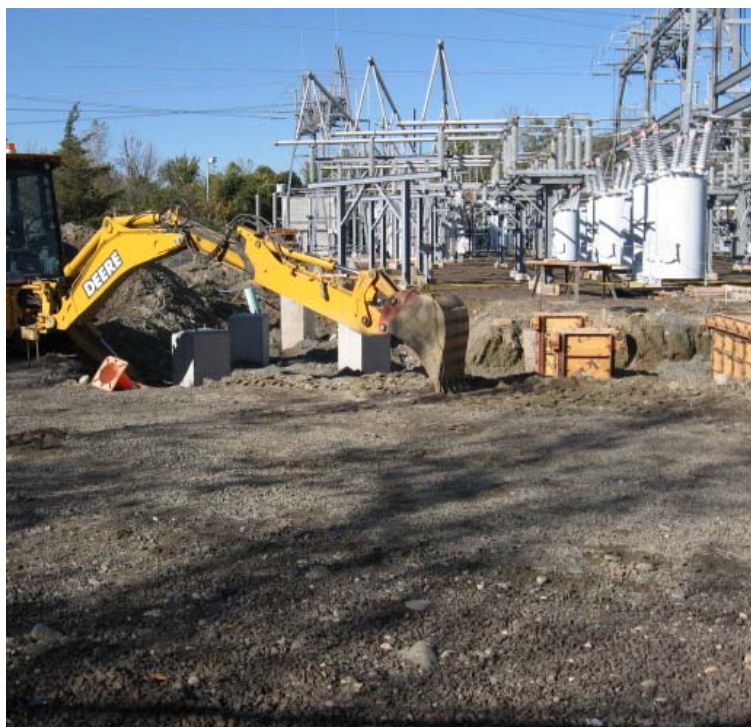
(Plumtree Substation): Photo on the left shows excavation occurring in the southern portion of the substation yard. This is not project jurisdictional. Photo on the right shows a view of the completed structures for the project in the northern portion of the yard 10/13/06.
